Occurrence of substances of concern in Baltic Sea Region buildings, construction materials and sites

NHC3 GoA2.1. Deliverable D.2.1

June 2024

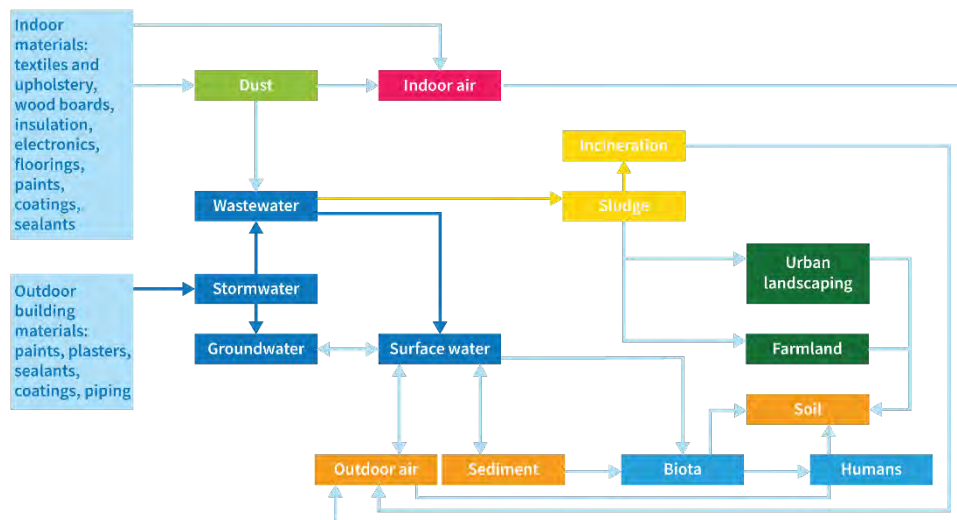
Figure 4. A Source map showing the sources of PFAS in construction products and the pathways into different reservoirs in the indoor and outdoor environment.

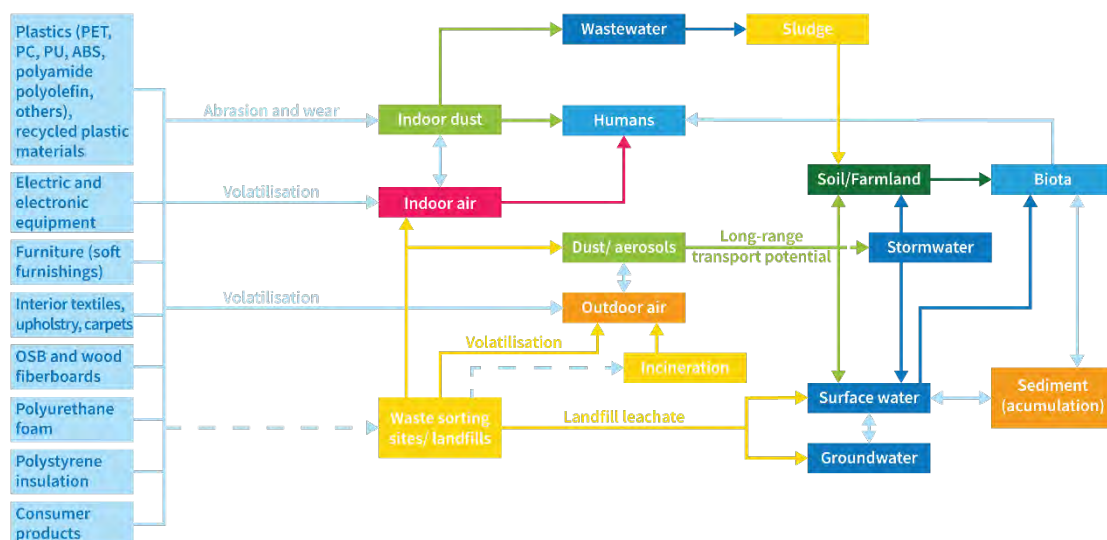
Figure 7. A Source map showing the sources of brominated flame retardants in construction products and the pathways into different reservoirs in the indoor and outdoor environment.

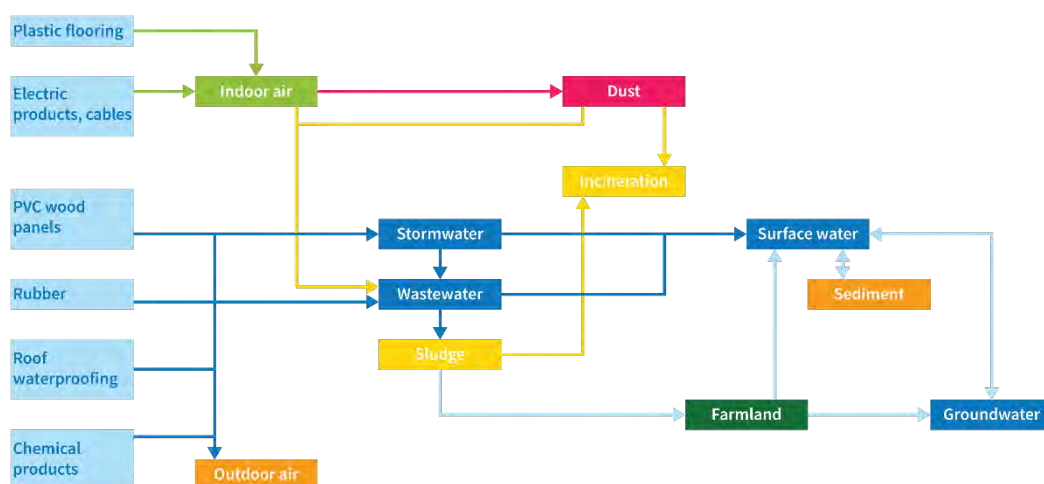
Figure 9. A Source map showing the sources of chlorinated paraffins in construction products and the pathways into different reservoirs in the indoor and outdoor environment.

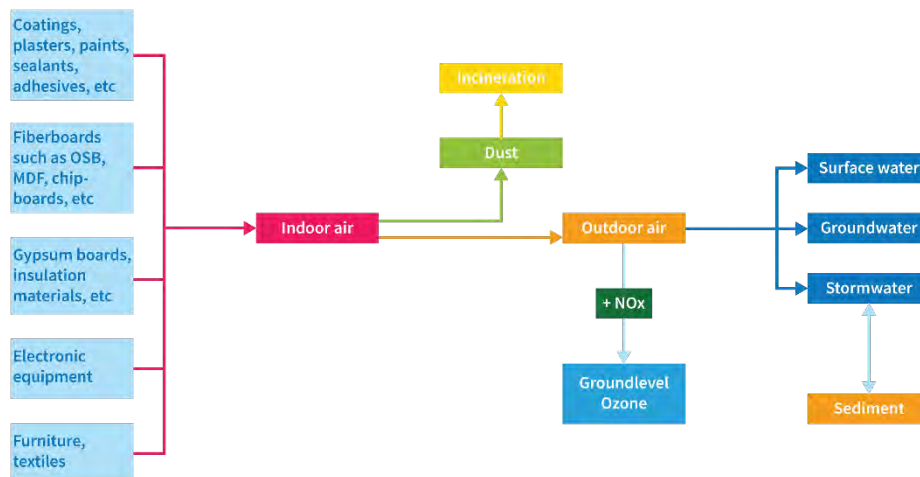
Figure 10. A Source map showing the sources of VOCs in construction products and the pathways into different reservoirs in the indoor and outdoor environment.

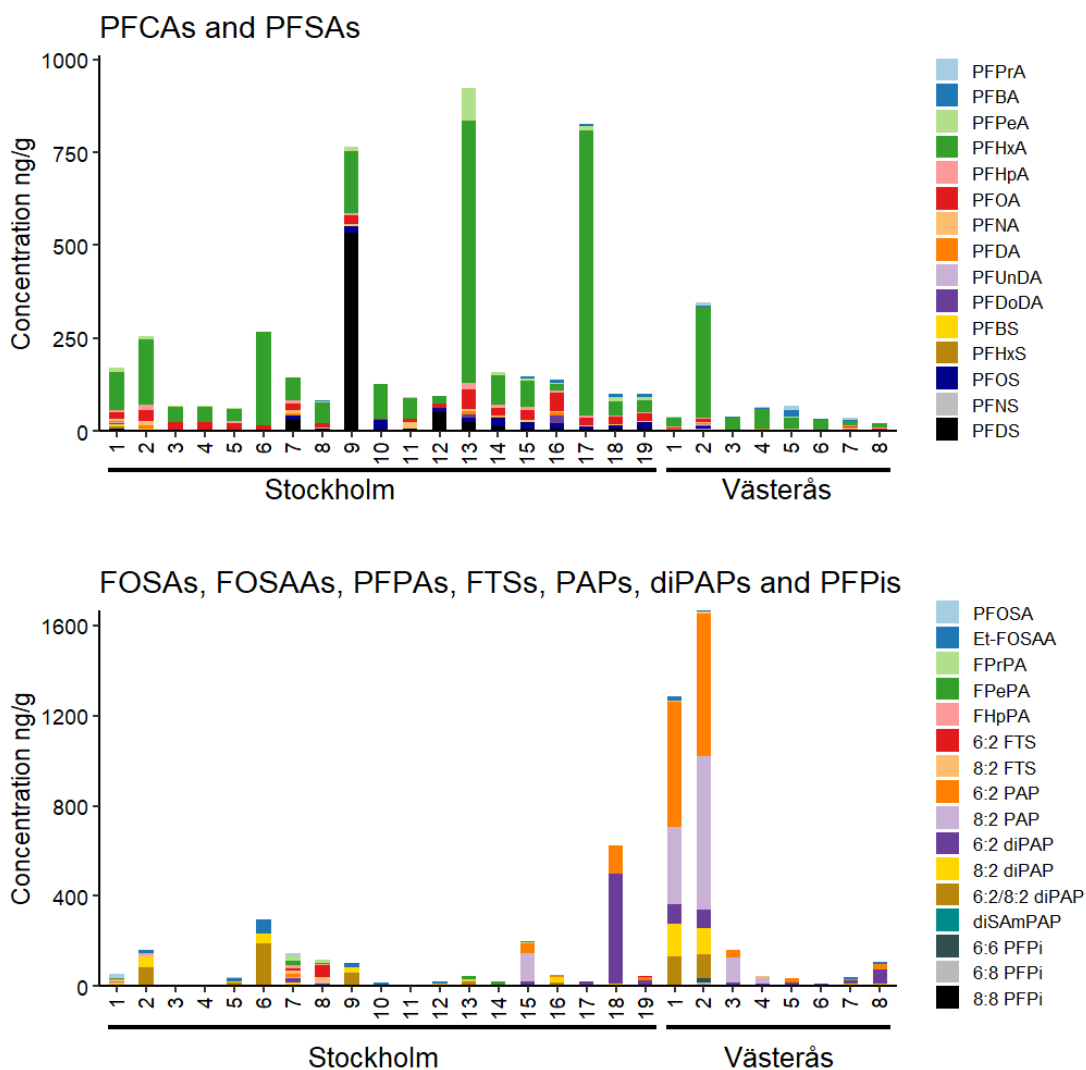
Figure 14. PFAS in preschool dust in Stockholm and Västerås. PFAS in preschool dust in Stockholm and Västerås. The upper diagram shows perfluorinated carboxylic (PFCA) and sulphonic acids (PFSA), and the lower diagram shows other investigated PFAS, many of which so called precursors, meaning they can degrade into persistent PFCAs or PFSA.

PFAS analysis was conducted on preschool dust samples collected in Stockholm and Västerås, with a total of 26 samples taken. The distribution of PFAS compounds is depicted in Figure 14. A broad range and distribution of PFAS substances were observed. Generally, Stockholm exhibited the highest concentrations of PFAS in the category of "sulfonates and carboxylic acids" (PFHxA 766 ng/g), while Västerås recorded the highest concentrations in the category of "telomers" (8:2 PAP 682 ng/g). Among the preschools included in this study, there appeared to be a few samples or preschools that had levels of certain substances that were three times as high as others. In this study, we observed an indication about relationship between PFAS in dust and the PVC flooring material used in a preschool in Västerås (Appendix 4). As a result, by supplier's dialogue in Västerås, we retrieved information on the use of floor polish. In general, floor/ furniture polish products may contain PFAS. Therefore, further investigation is needed to back track from where the PFAS comes from and therefore take measures on how to avoid PFAS in preschools.

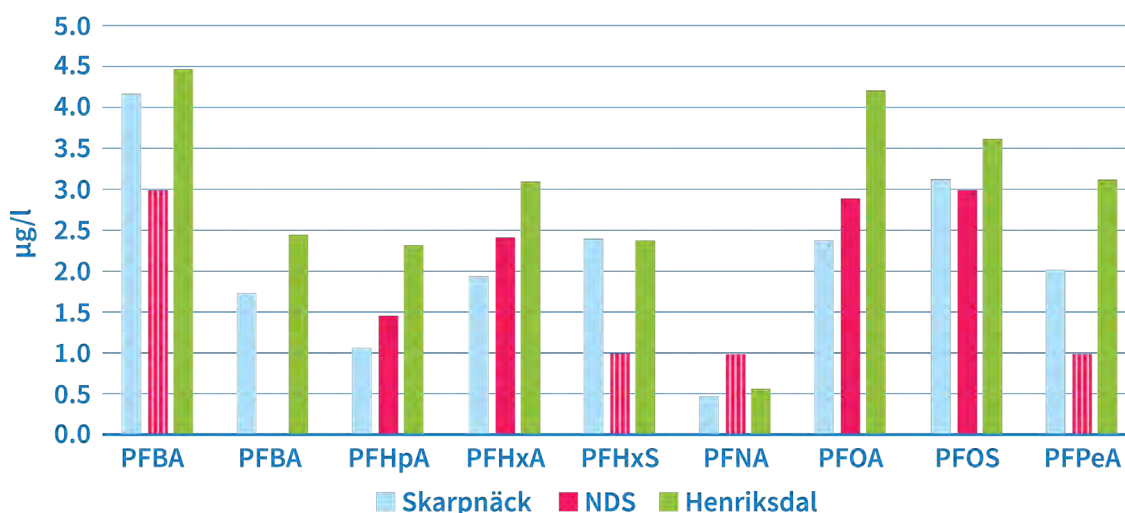
Figure 18. The concentration of PFAS in domestic wastewater from Skarpnäck, NDS and influent wastewater to Henriksdal WWTP 2020-2023. The striped bars show the limit of quantification (LOQ). For PFBS in wastewater from NDS 4 out of 7 samples were <LOD.

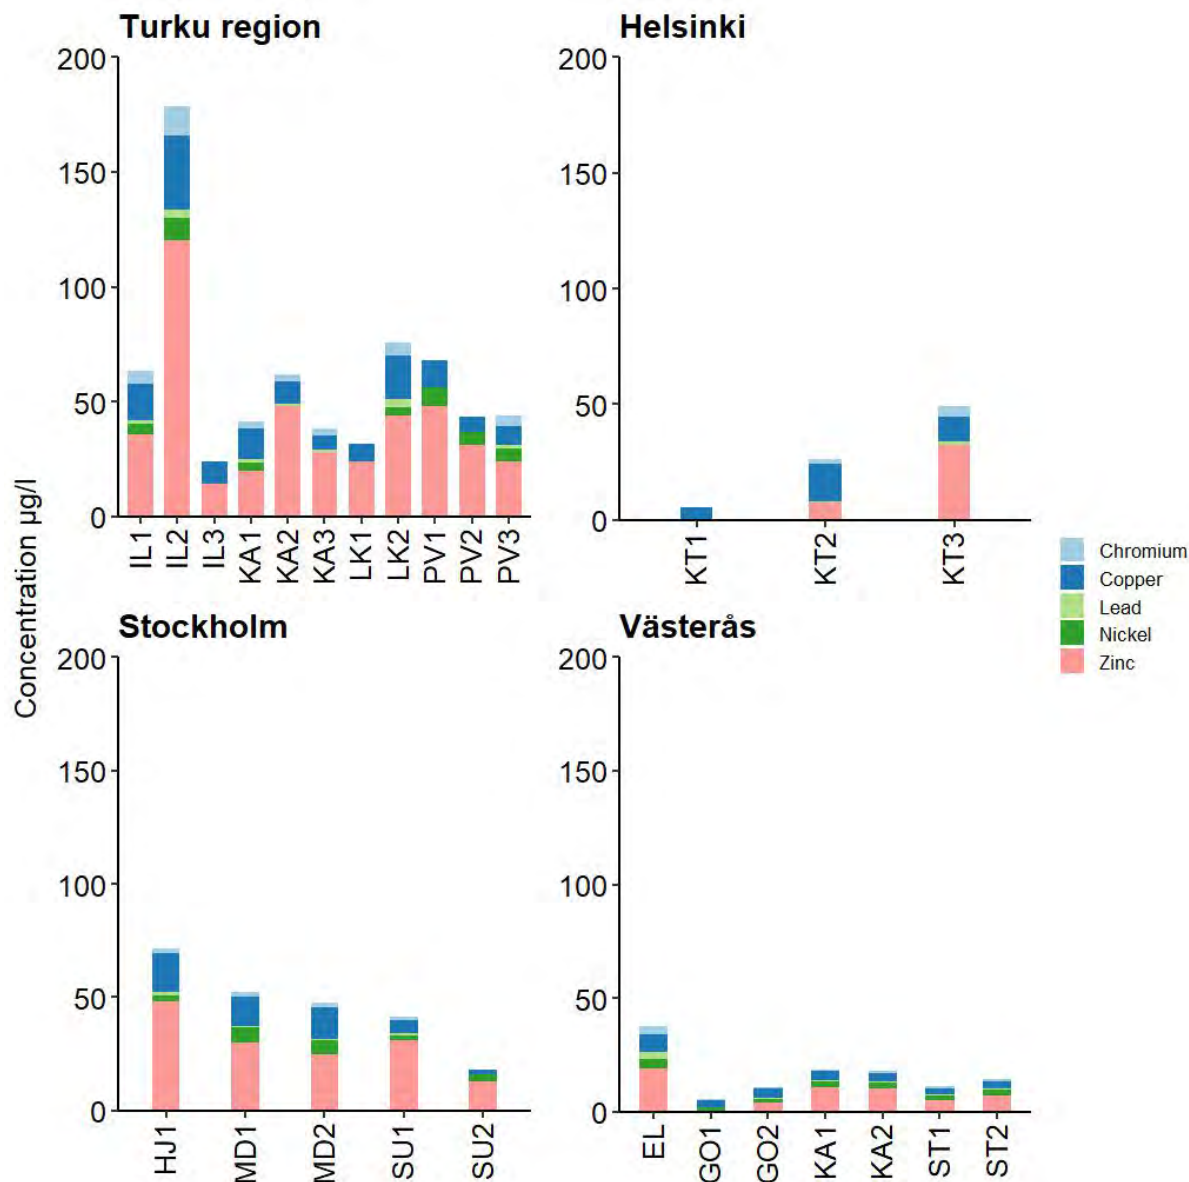
Figure 19. Metals in stormwater in Turku, Helsinki, Stockholm, Västerås. The x-axis designates different sample sites explained in Appendices 1,2,4,5A.

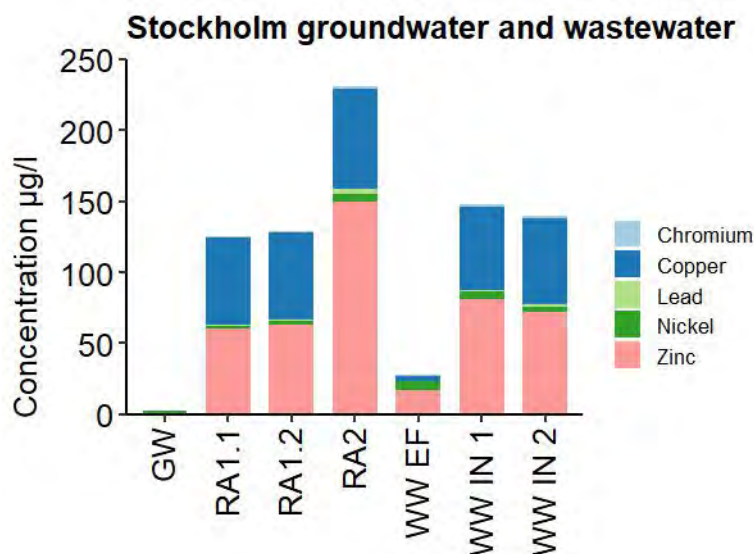
Figure 20. Metals in groundwater and wastewater in Stockholm. GW-groundwater, RA-wastewater from residential areas, WW-wastewater (treatment plant), EF – effluent, IN-inlet.

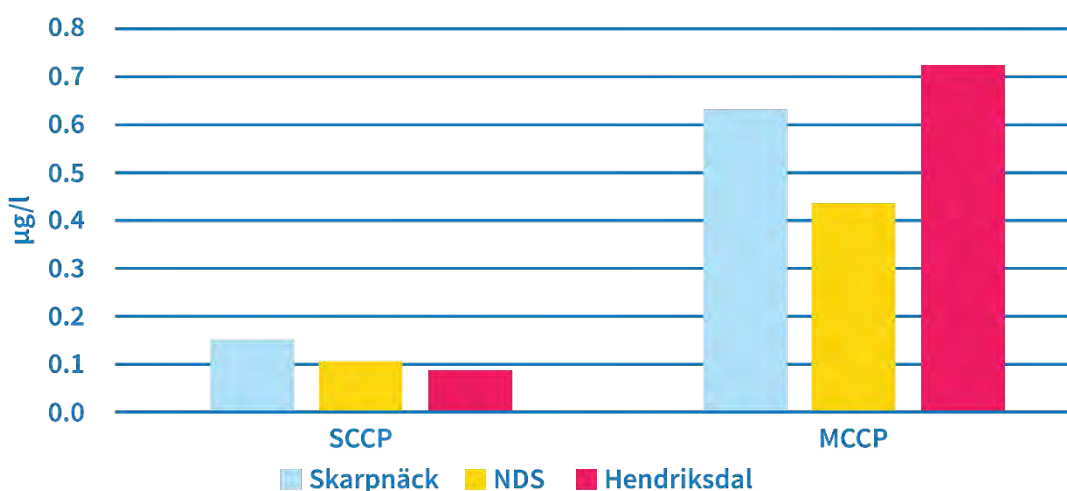
Figure 21. Chlorinated paraffins in wastewater. Skarpnäck and NDS is domestic waste water from residential areas and Hendriksdal is inlet to the WWTP.

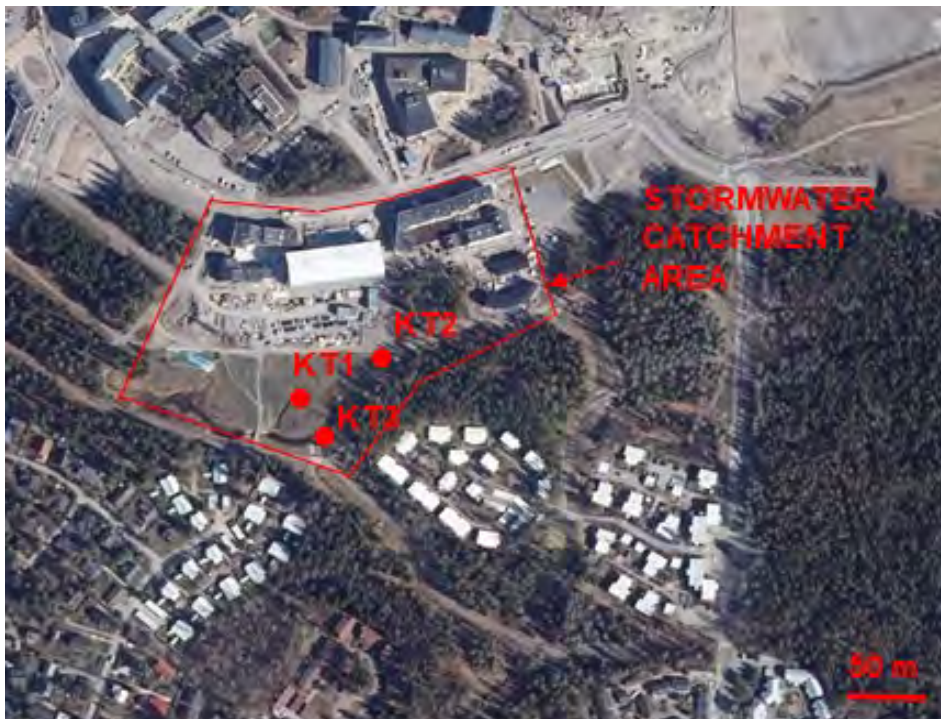
Picture 6. Aerial photo of Kuninkaantammi area with stormwater catchment area and sampling locations.

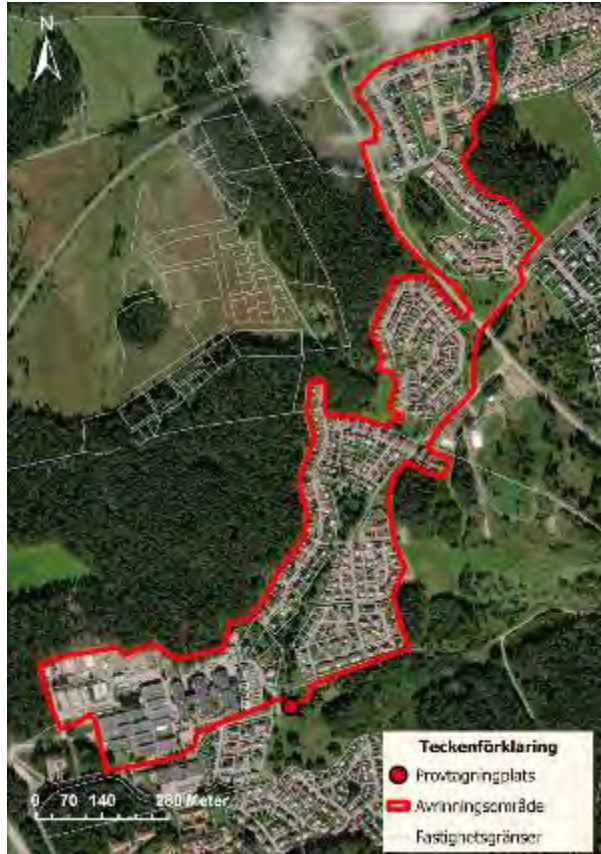
Figure 1, Aerial photo of EL catchment area with sampling location. The catchment area is inside the red line and the red dot marks the sampling location.

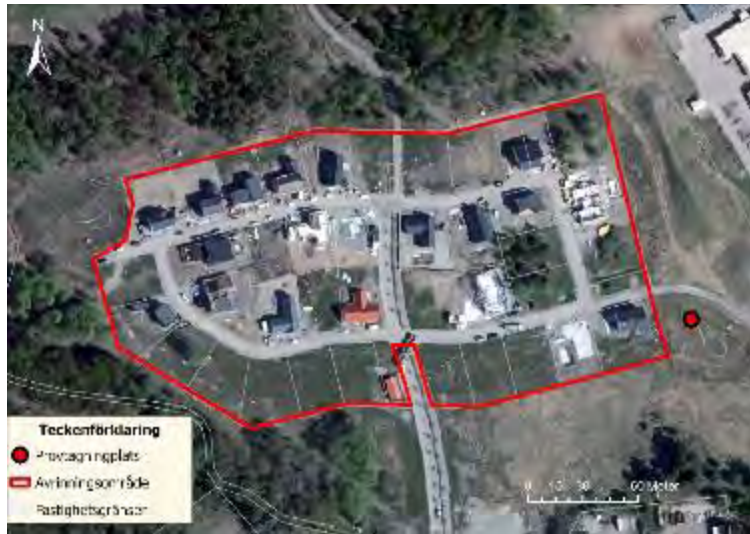
Figure 5, Aerial photo of KA catchment area with sampling location. The catchment area is inside the red line and the red dot marks the sampling location. Kain is located northwest just outside the catchment area. The red dot indicates the sampling location for KA1, KA2 and KAout.

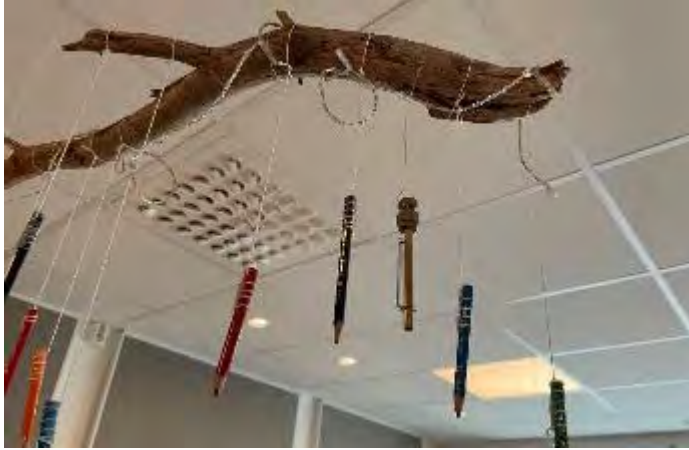
Figure 19, VOC sampler installed next to pencil-crayons in Vas6 location.

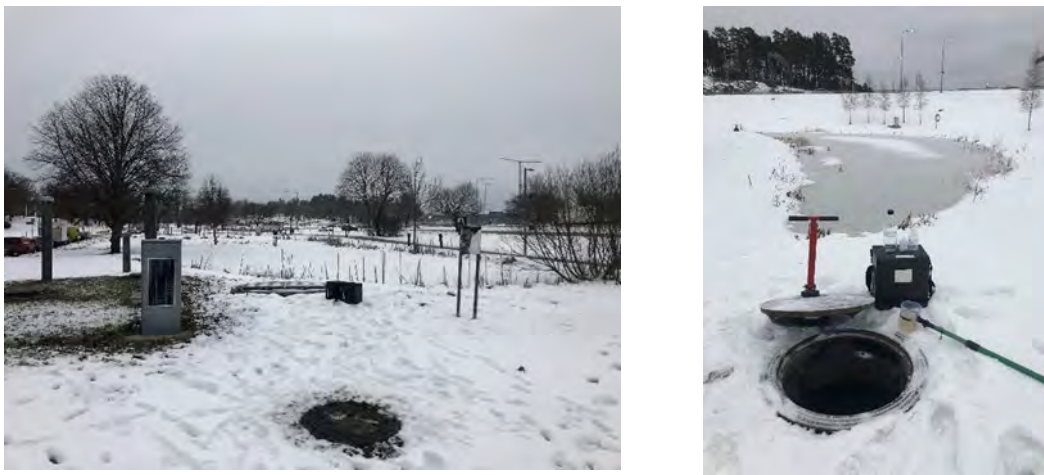
Figure 8. Examples of sampling locations and equipment used for stormwater sampling.

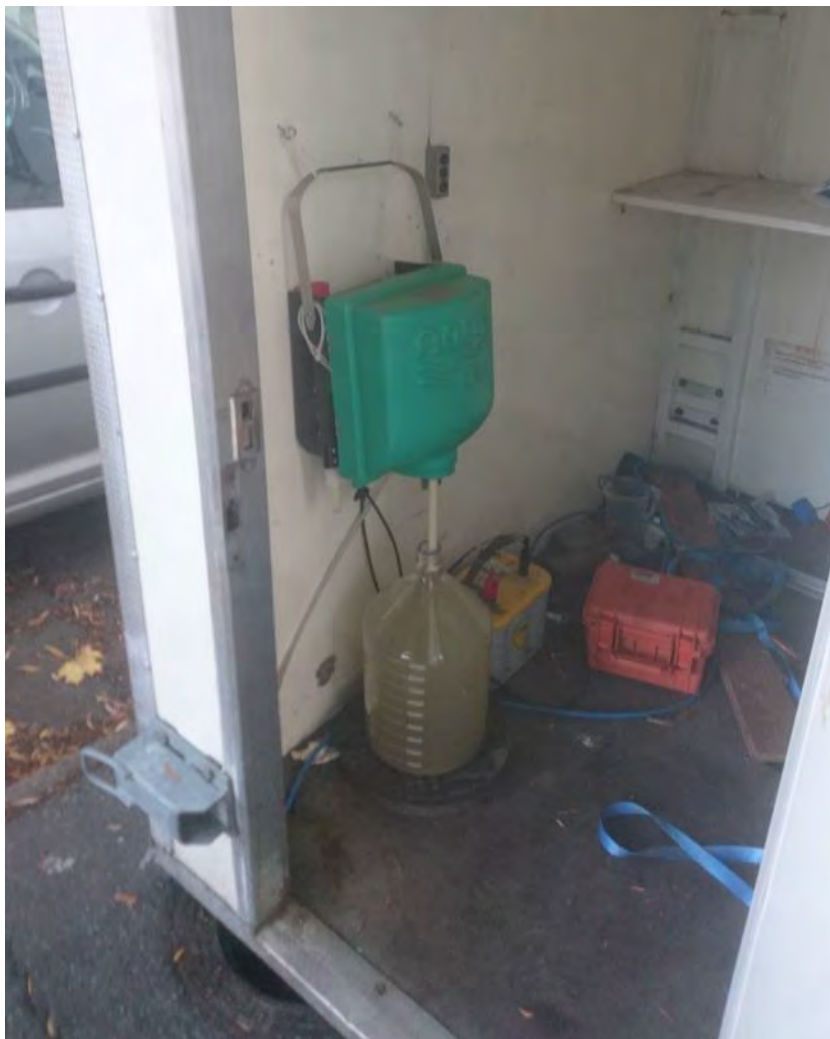
Figure 1. Sampling equipment, Skarpnäck

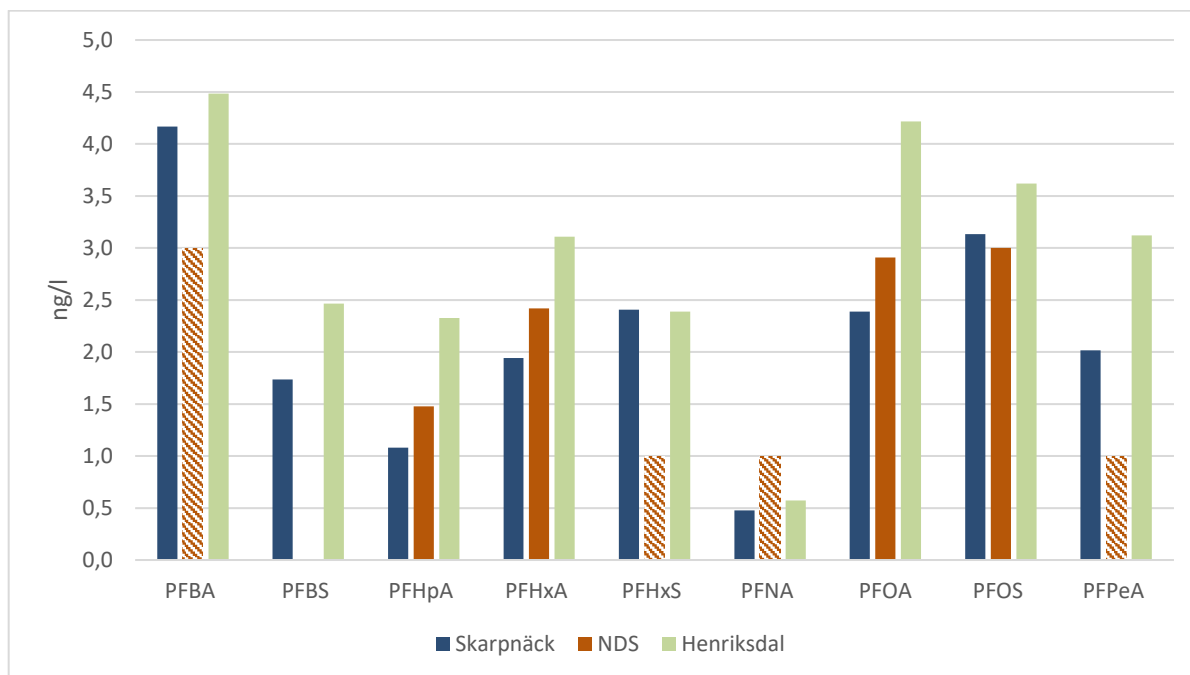
Figure 8. The concentration of PFAS in domestic wastewater from Skarpnäck, NDS and influent wastewater to Henriksdal WWTP 2020-2023. The striped bars show the limit of quantification (LOQ). For PFBS in wastewater from NDS 4 out of 7 samples were <LOD.
