# TRUST ALUM

## The TRUST ALUM project

## Lake Velnezers – a lake restoration pioneer

# 10 facts about the treatment of Lake Velnezers

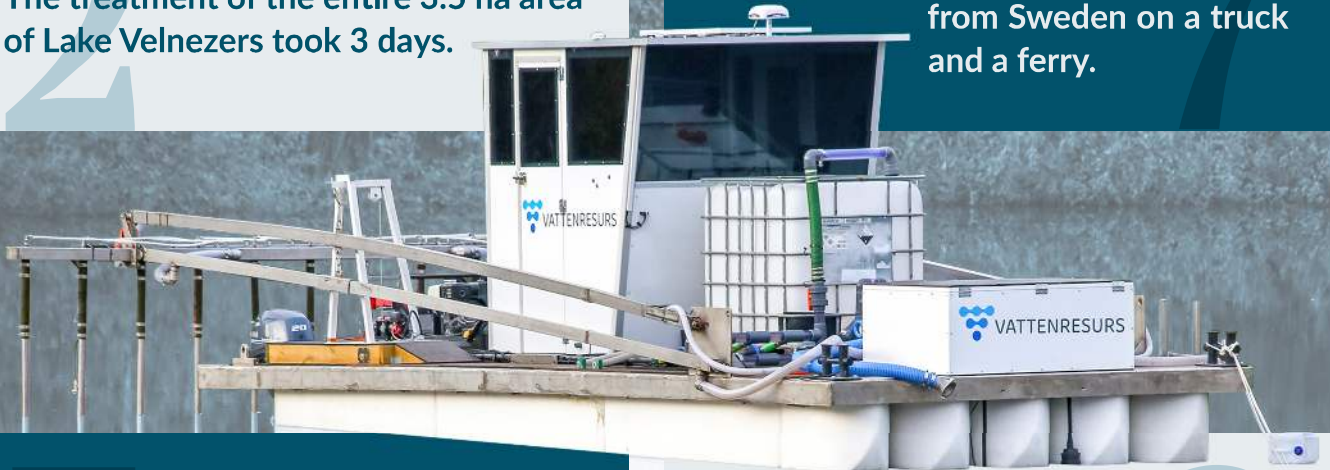
**1** The boat has the capacity to hold 4 tonnes of PAC. It required 4 refills to treat the entire lake.

**2** The treatment of the entire 3.5 ha area of Lake Velnezers took 3 days.

**3** PAC was pumped into the boat from containers on land. It took 25 min to pump each container into the boat.

**4** PAC was distributed approximately 10 cm deep into the lake sediments.
